## **Rack bolt replacement: Parkes Telescope**

**Lewis Ball**

6 Feb 2002

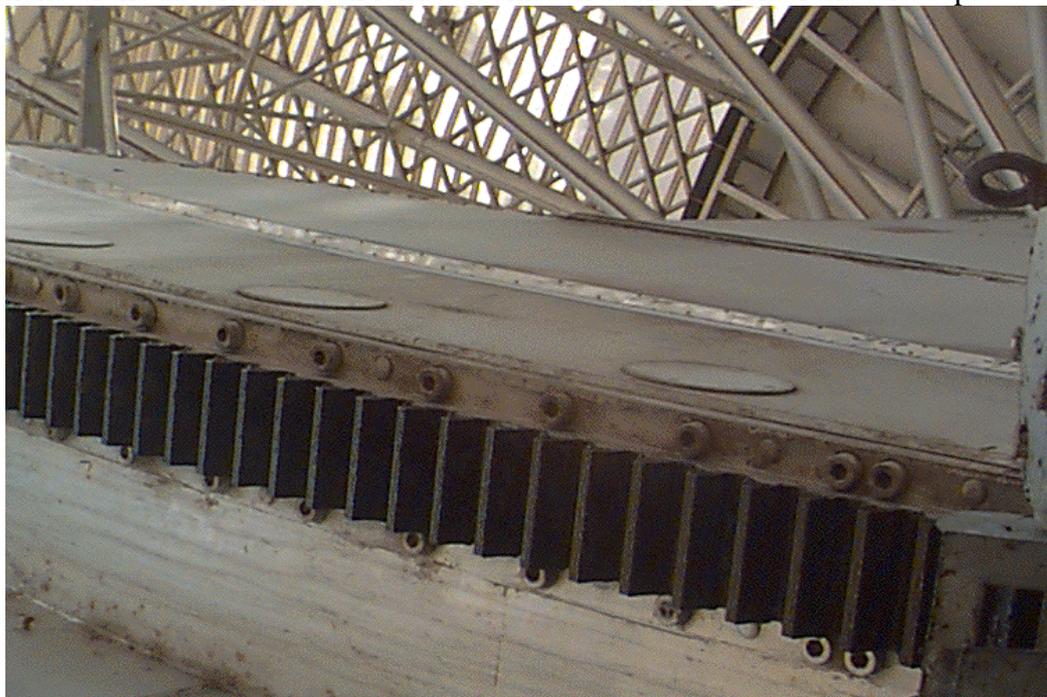
**Fig 1:** View of the right rack showing (face on) the rack teeth and bolt heads and (side on) the round access covers.

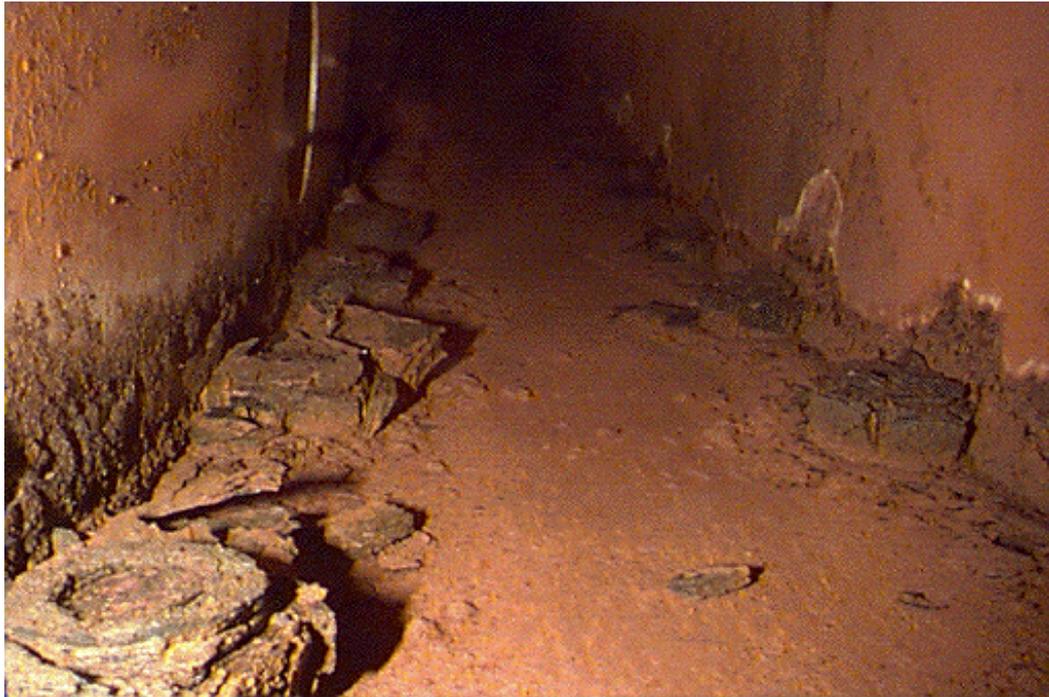
Inspection of the nuts was only possible after the removal of one or more access covers on the sides of the counterweight. There were no external indications of the corrosion that was found inside the cavity, and it seems that prior to November 2001 none of the covers had been removed since the construction of the telescope.

It was decided on the basis of the visual inspection of the nuts and bolts, and the ultrasonic testing of the dowels, that there was no danger of immediate mechanical failure of the rack mounting, but that the corrosion was so extreme that replacement of the bolts and nuts was required as soon as scheduling allowed.

**Fig 2:** Corroded rack nuts and bolts inside the counterweight cavity.

Plans for the full job were developed on the basis of the trial. The aim was to ensure replacement of all the bolts and nuts, removal and cleaning of all the corrosion within the counterweight cavity, treatment of the cavity with rust converter, and sealing of the cavity with an epoxy paint compound. To meet the target of completing this work within a seven day shutdown, making allowance for possible interruptions due to wind or other bad weather, and for other contingencies, the use of contract engineering labour to supplement staff from Parkes, Narrabri, and Marsfield was required. The team directly involved in the work on the bolts comprised: Jon Crocker, Barry Turner, and Brett Preisig from Parkes; Clive Murphy and Graeme Sunderland from Narrabri; and Paul Cooper and Brian Wilcockson from Marsfield. These staff were supplemented by a team of five from G Engineering, based in Blayney. A draft schedule of work comprised two shifts, from 5am - 2pm and from 2pm to 11 pm. The G Engineering contract allowed for the company's employees to work up to 12 hours per 24 hour period and the rate was a fixed \$36/hour regardless of which hours were worked during the day.

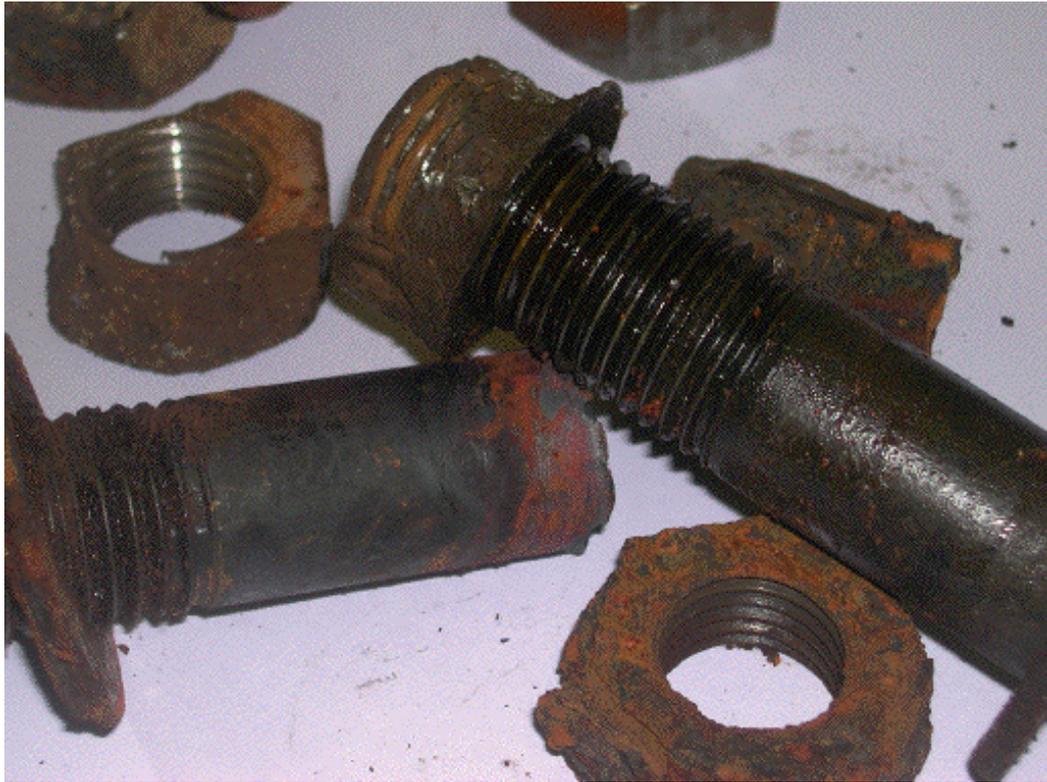
**Fig 4:** Some of the worst of the nuts.

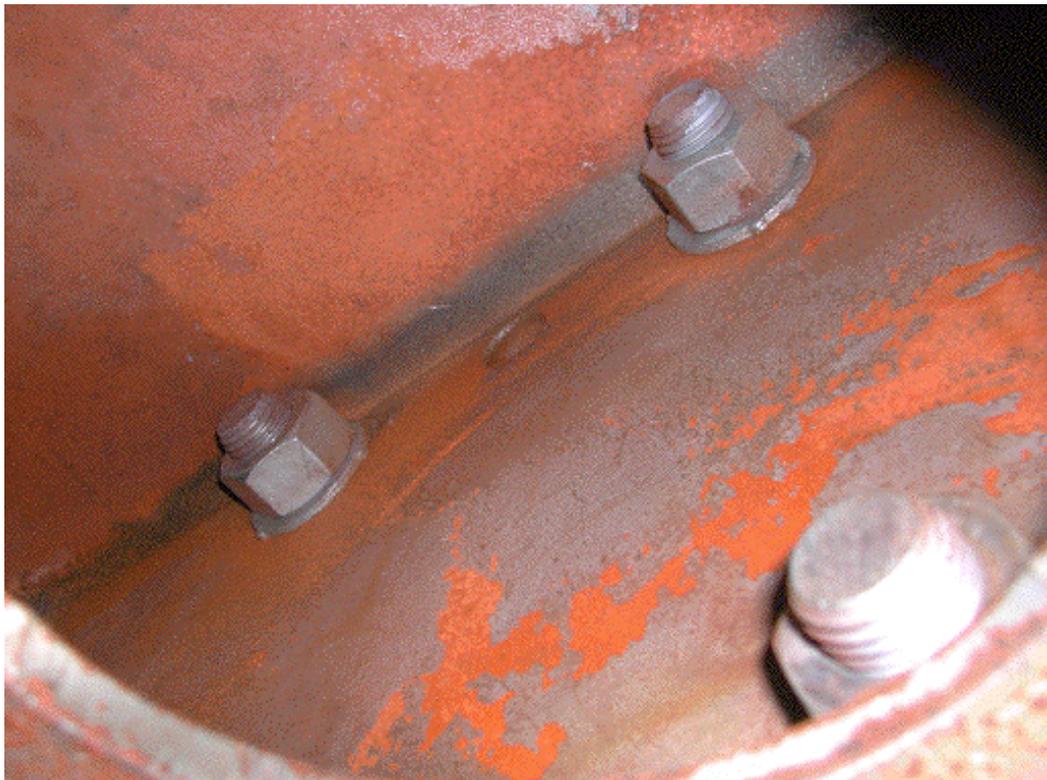
**Fig 5:** Cleaned up with new bolts and nuts. Note recessed tapered dowel.

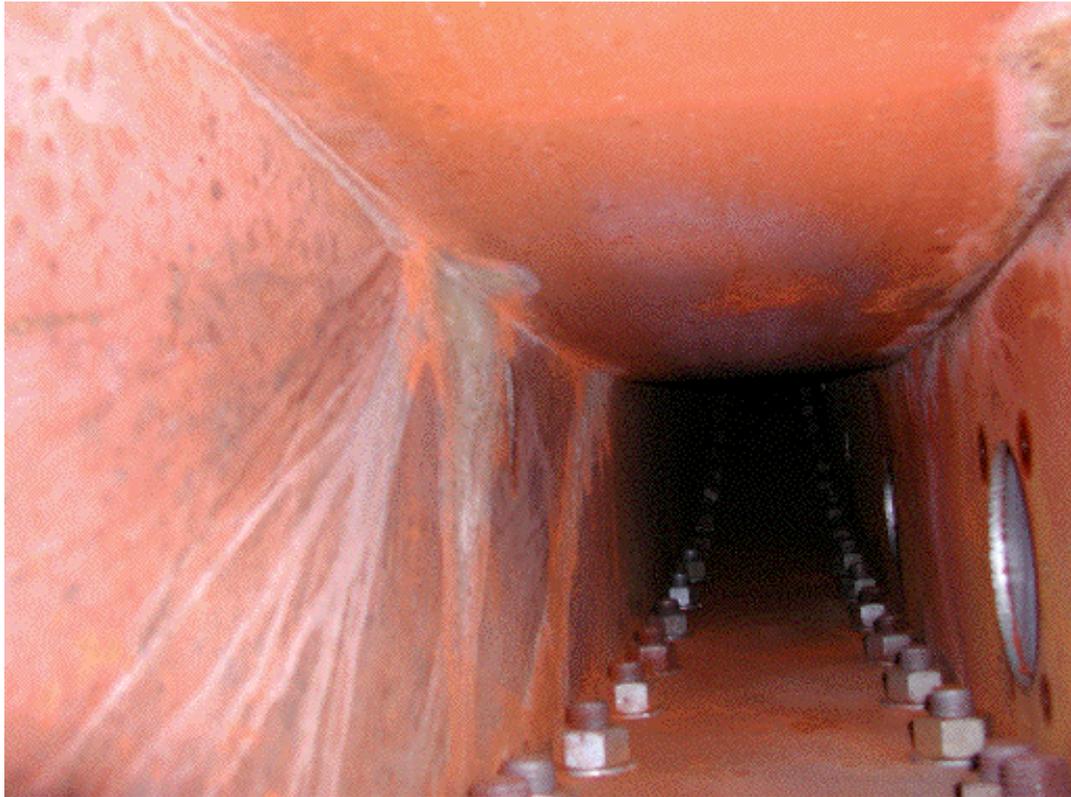
Inspections conducted during the work indicated that seepage of moisture from the counterweight itself into the rack bolt cavity was the most likely source of the corrosion. A number of drain holes were drilled in the counterweight and breathers were fitted to the rack bolt cavity to facilitate the removal of moisture from these areas. Around 40 litres of water flowed from one hole drilled in the main counterweight cavity!

**Fig 6:** Signs of moisture ingress.

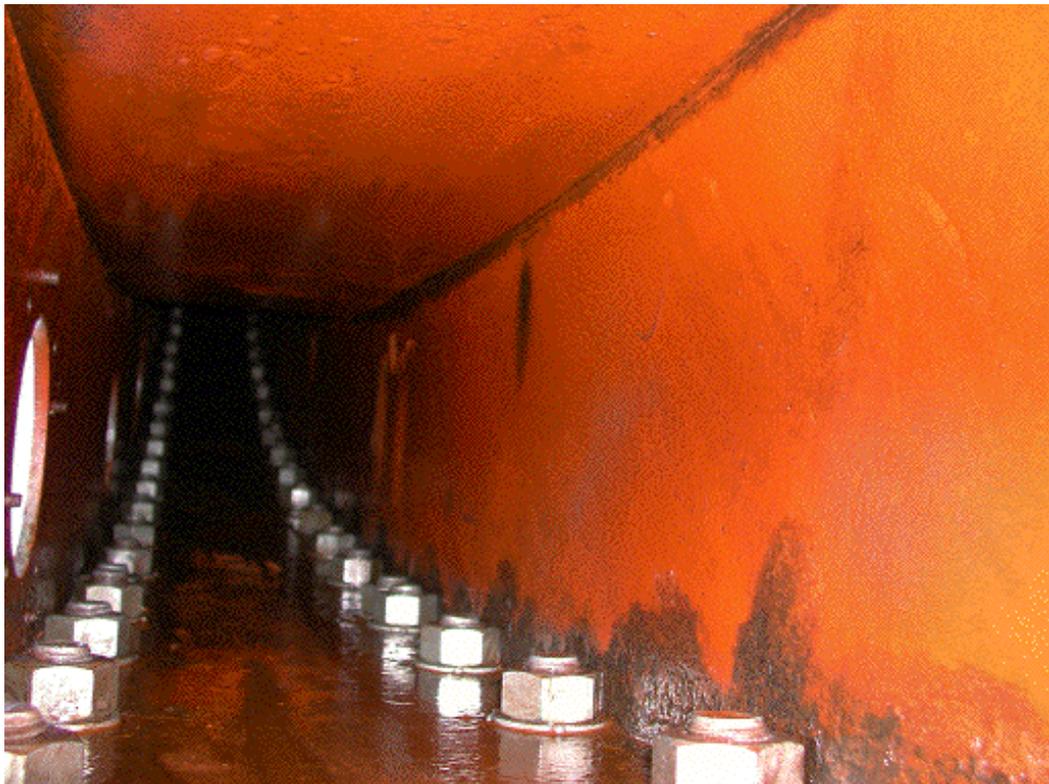
**Fig 6:** After rust converter application. Dark areas are neutralised rust.

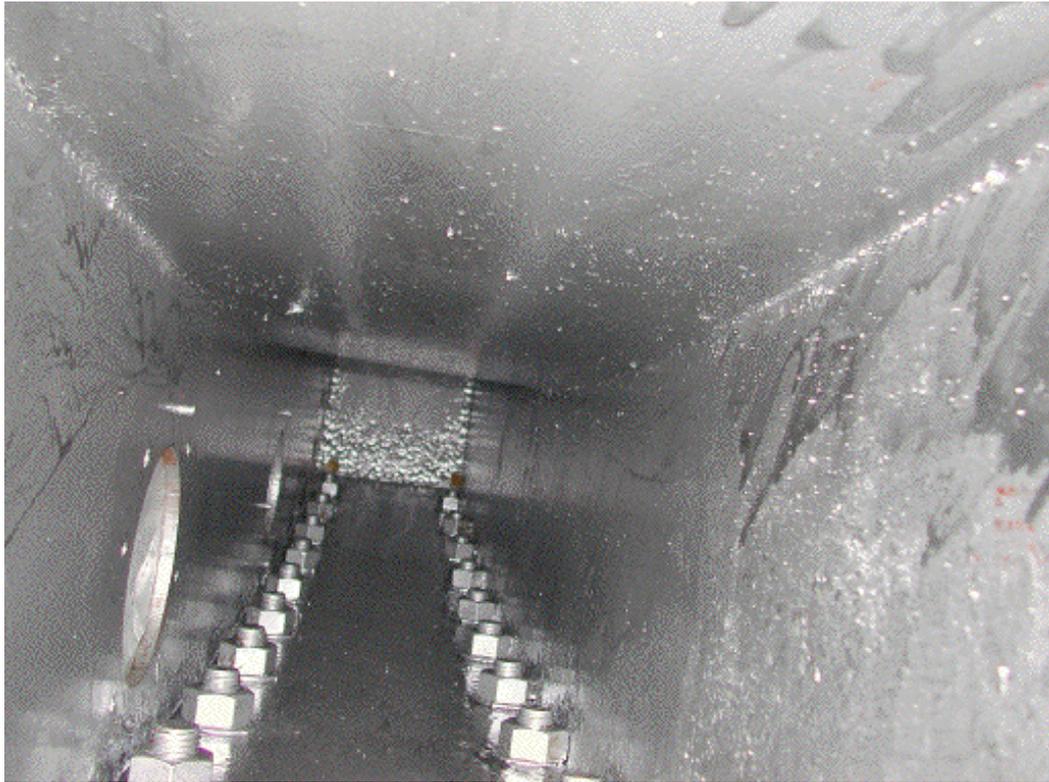
**Fig 7:** The finished job. Dark patches at the bottom are new drain holes.

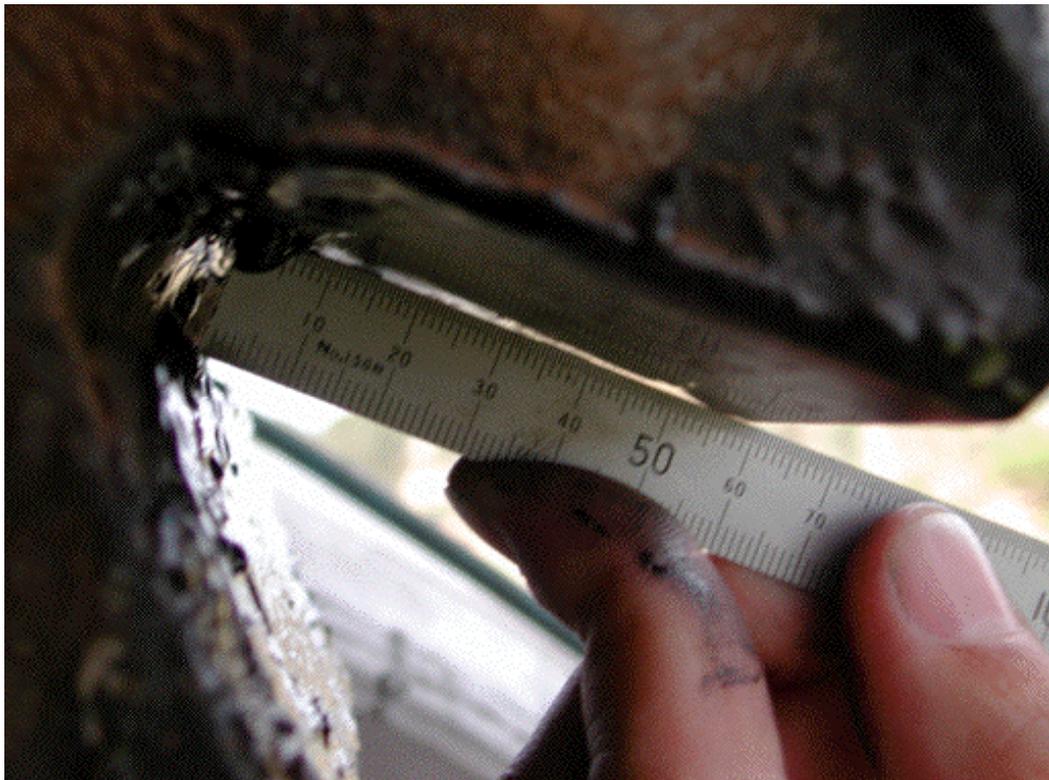
be replaced sometime in 2002. The racks are badly worn on one face, and there is a strong imperative to address this at the same time as the gearboxes and pinions are replaced.

**Fig 8:** Wear on the rack teeth (still to be remedied).
