AT Technical Data
AT39.2/020
November 22, 1993

THE AUSTRALIA TELESCOPE NATIONAL FACILITY
PHASE JUMPS IN THE AT PHASE ROTATOR MODULES

Andrew Bish

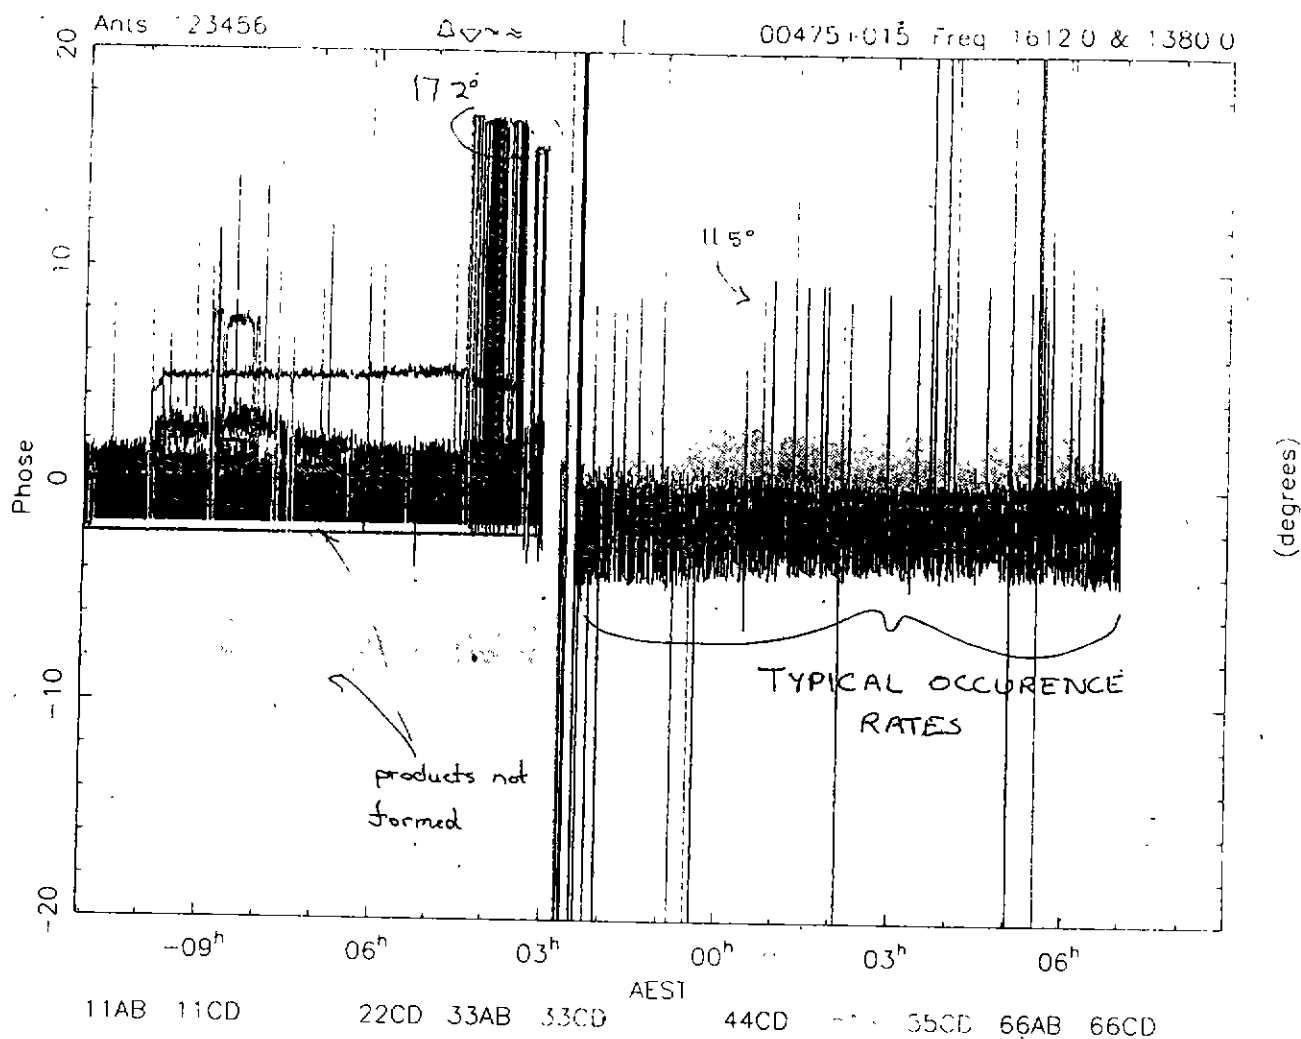
Figure 1 : Errors in start phases caused by the L21/L22 Modules

Nearly all the spikes here result from incorrect start phases, however those in the region extending from -11h to -3hr include some artifacts resulting from the correlator not forming the 'AB' products. In the 'typical' region, there appears to be quite a large number of low level phase jumps (of the order of 1-2 degrees), as well as one of > 5 degrees every 6 minutes

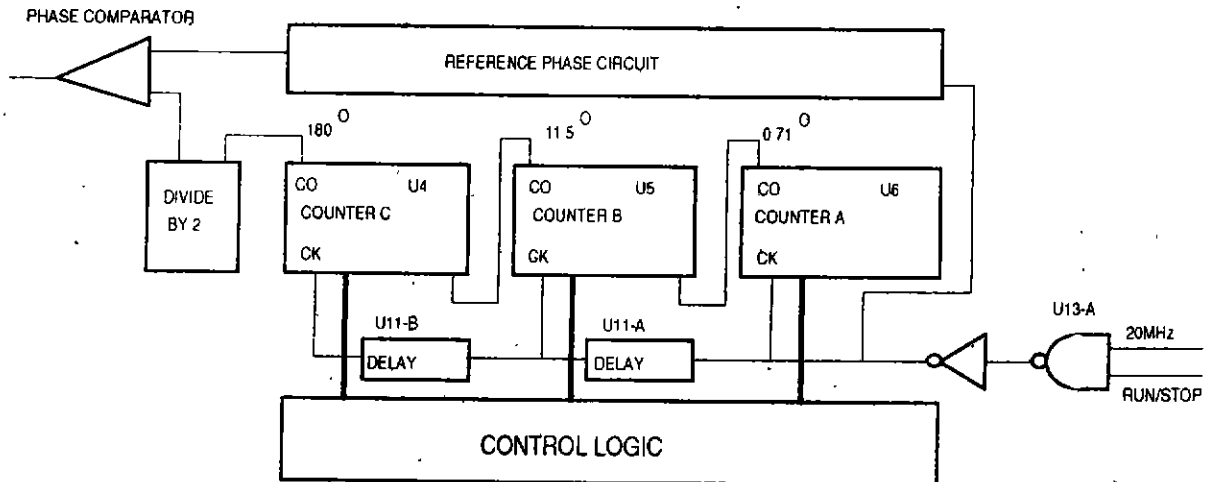
Figure 2: Divide by 2000 loop in L21/L22 Modules

set (111111). Some analysis eventually showed that this resulted when the first clock pulse at the start of an integration cycle did not properly clock a series of three 4-bit counters (74ALS168's). That is, the most significant counter (counter 'C' in figure 2 below) was not clocked whilst A & B were.

A noticeable error occurs when a counter is fully loaded and receives a clock pulse which triggers it but not the next (more significant) counter. This means all the previous counts are lost when CO (the carry look ahead) goes low. The angles shown are those that result in a carry-look-ahead being set for the next counter.

This meant that when the carry-look-ahead of the second counter was set, then reset by the clock, this pulse would not clock into the most significant counter (C). This resulted in 64 counts being dropped, or that the start phase was incorrect by $64 \times 0.18^\circ = 11.5^\circ$. Further investigation showed that this was because the 20MHz signal that clocked the counters was asynchronously NEEDED with the event generator line. Hence at the beginning of an integration cycle the initial clock pulse could be very narrow (a glitch) which caused incorrect clocking of the rest of the circuit (see figure 3 below).

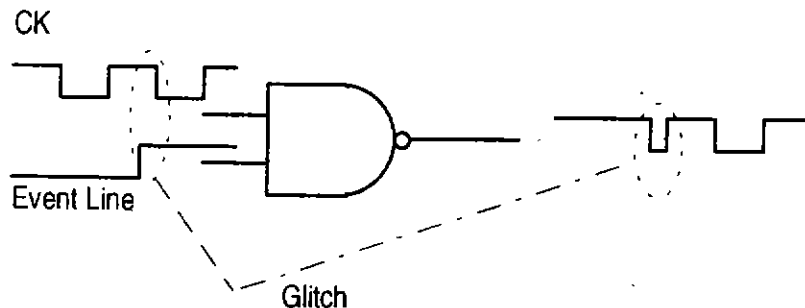
Figure 3: Asynchronous NAND Gate showing Glitch

The reason for such a glitch causing an error is because the clocking rates of the counters, and the operating speeds of the delay circuits are violated, causing

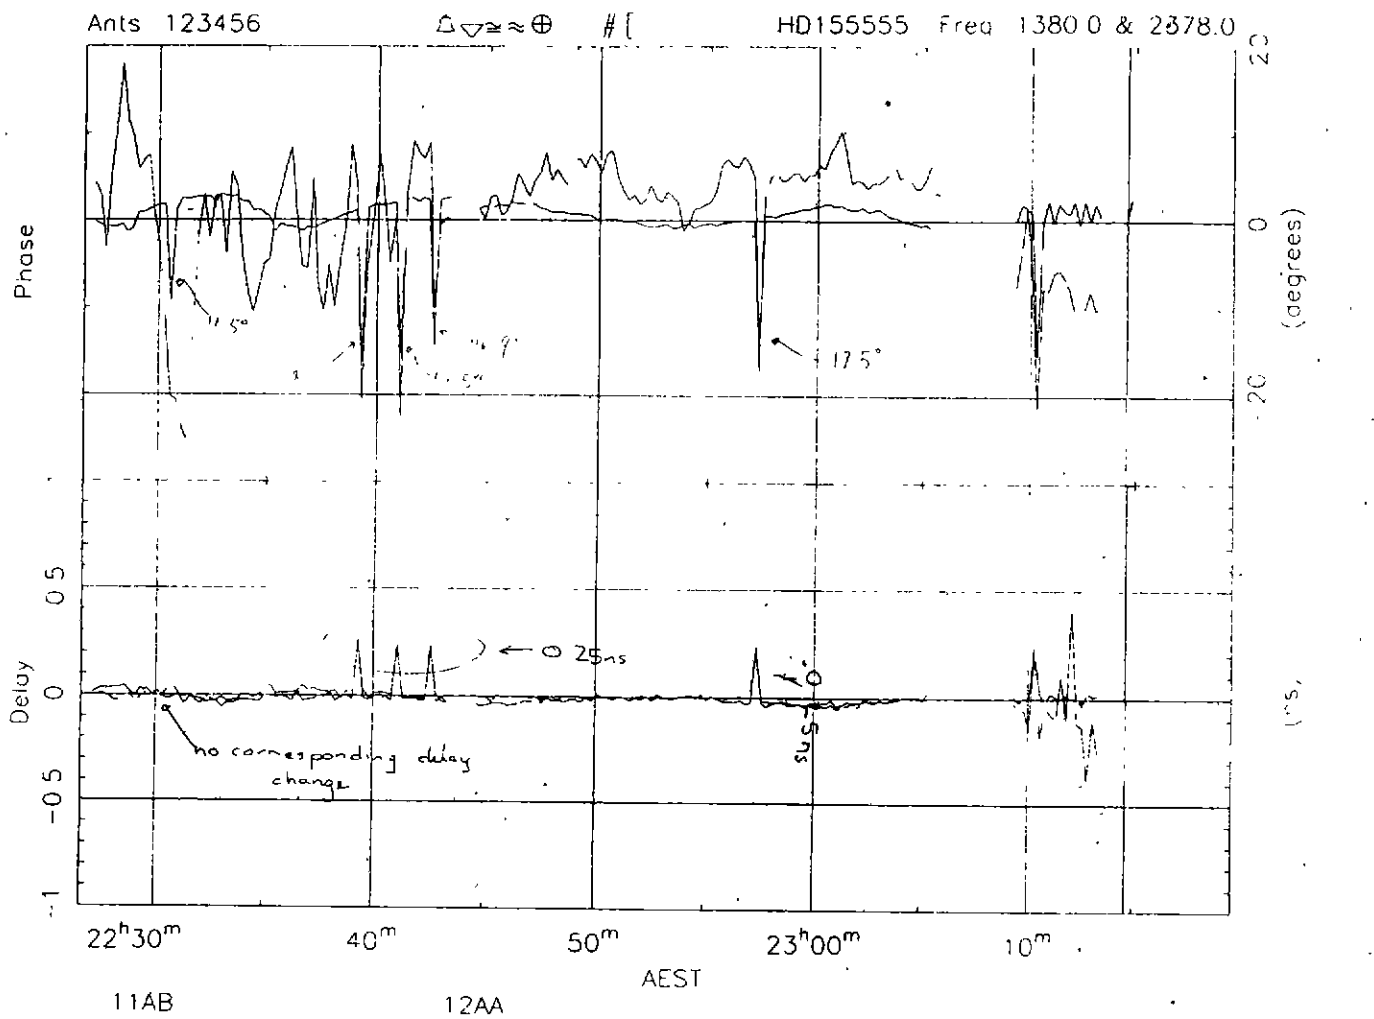
Figure 5: Delay corresponding to 17 degree jump.

To demonstrate this, in figure 5 all the 17° glitches correspond to a correlator delay glitch of 0.25ns as predicted by (3). The 11.5° glitches do not have any corresponding change of delay, since a wrong start phase on the UHF oscillator only causes a correlator phase error.
