THE AUSTRALIA TELESCOPE NATIONAL FACILITY

## Interference on the Compact Array and Shielding Recommendations

*Russell Gough*

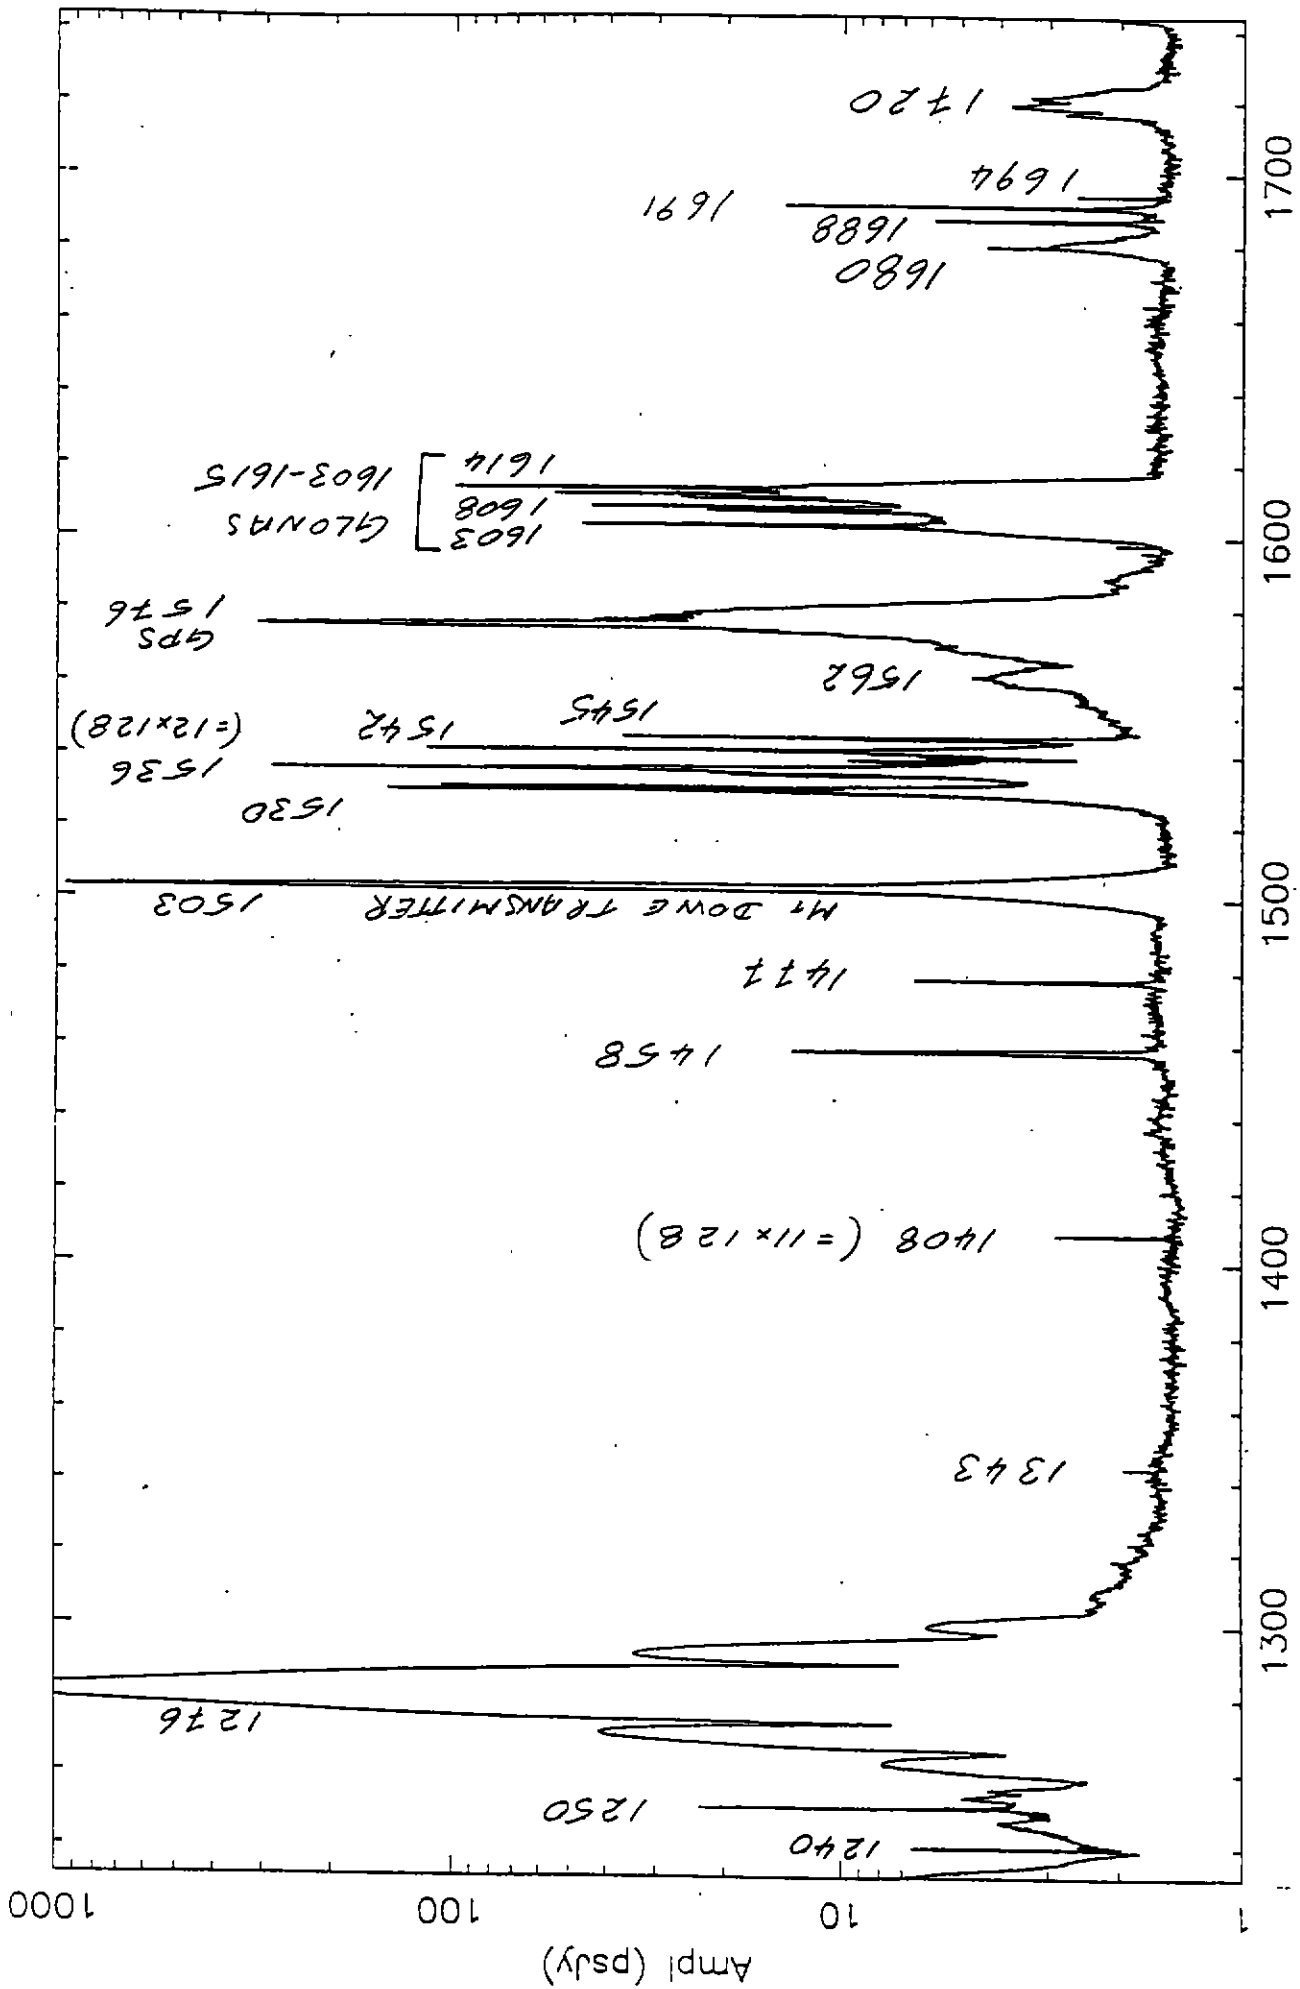
A survey of interference by Mark Wieringa and Ravi Subrahmanyan[1] shows that there is considerable interference in the 20 and 13 cm bands ( see Figs. 1 and 2 ). Figs. 3 and 4 [2] show less interference in the 6 and 3 cm bands.

The frequencies and sources of the interference in Figs. 1 to 4 are listed in Table 1. Although I have not yet identified all the sources of interference, it is clear that the worst interference in the 20 cm band is external to the AT antennas and comes from the GLONAS and GPS satellites and from terrestrial microwave links.

Fig. 1. Interference in the 20 cm band, taken from [1].

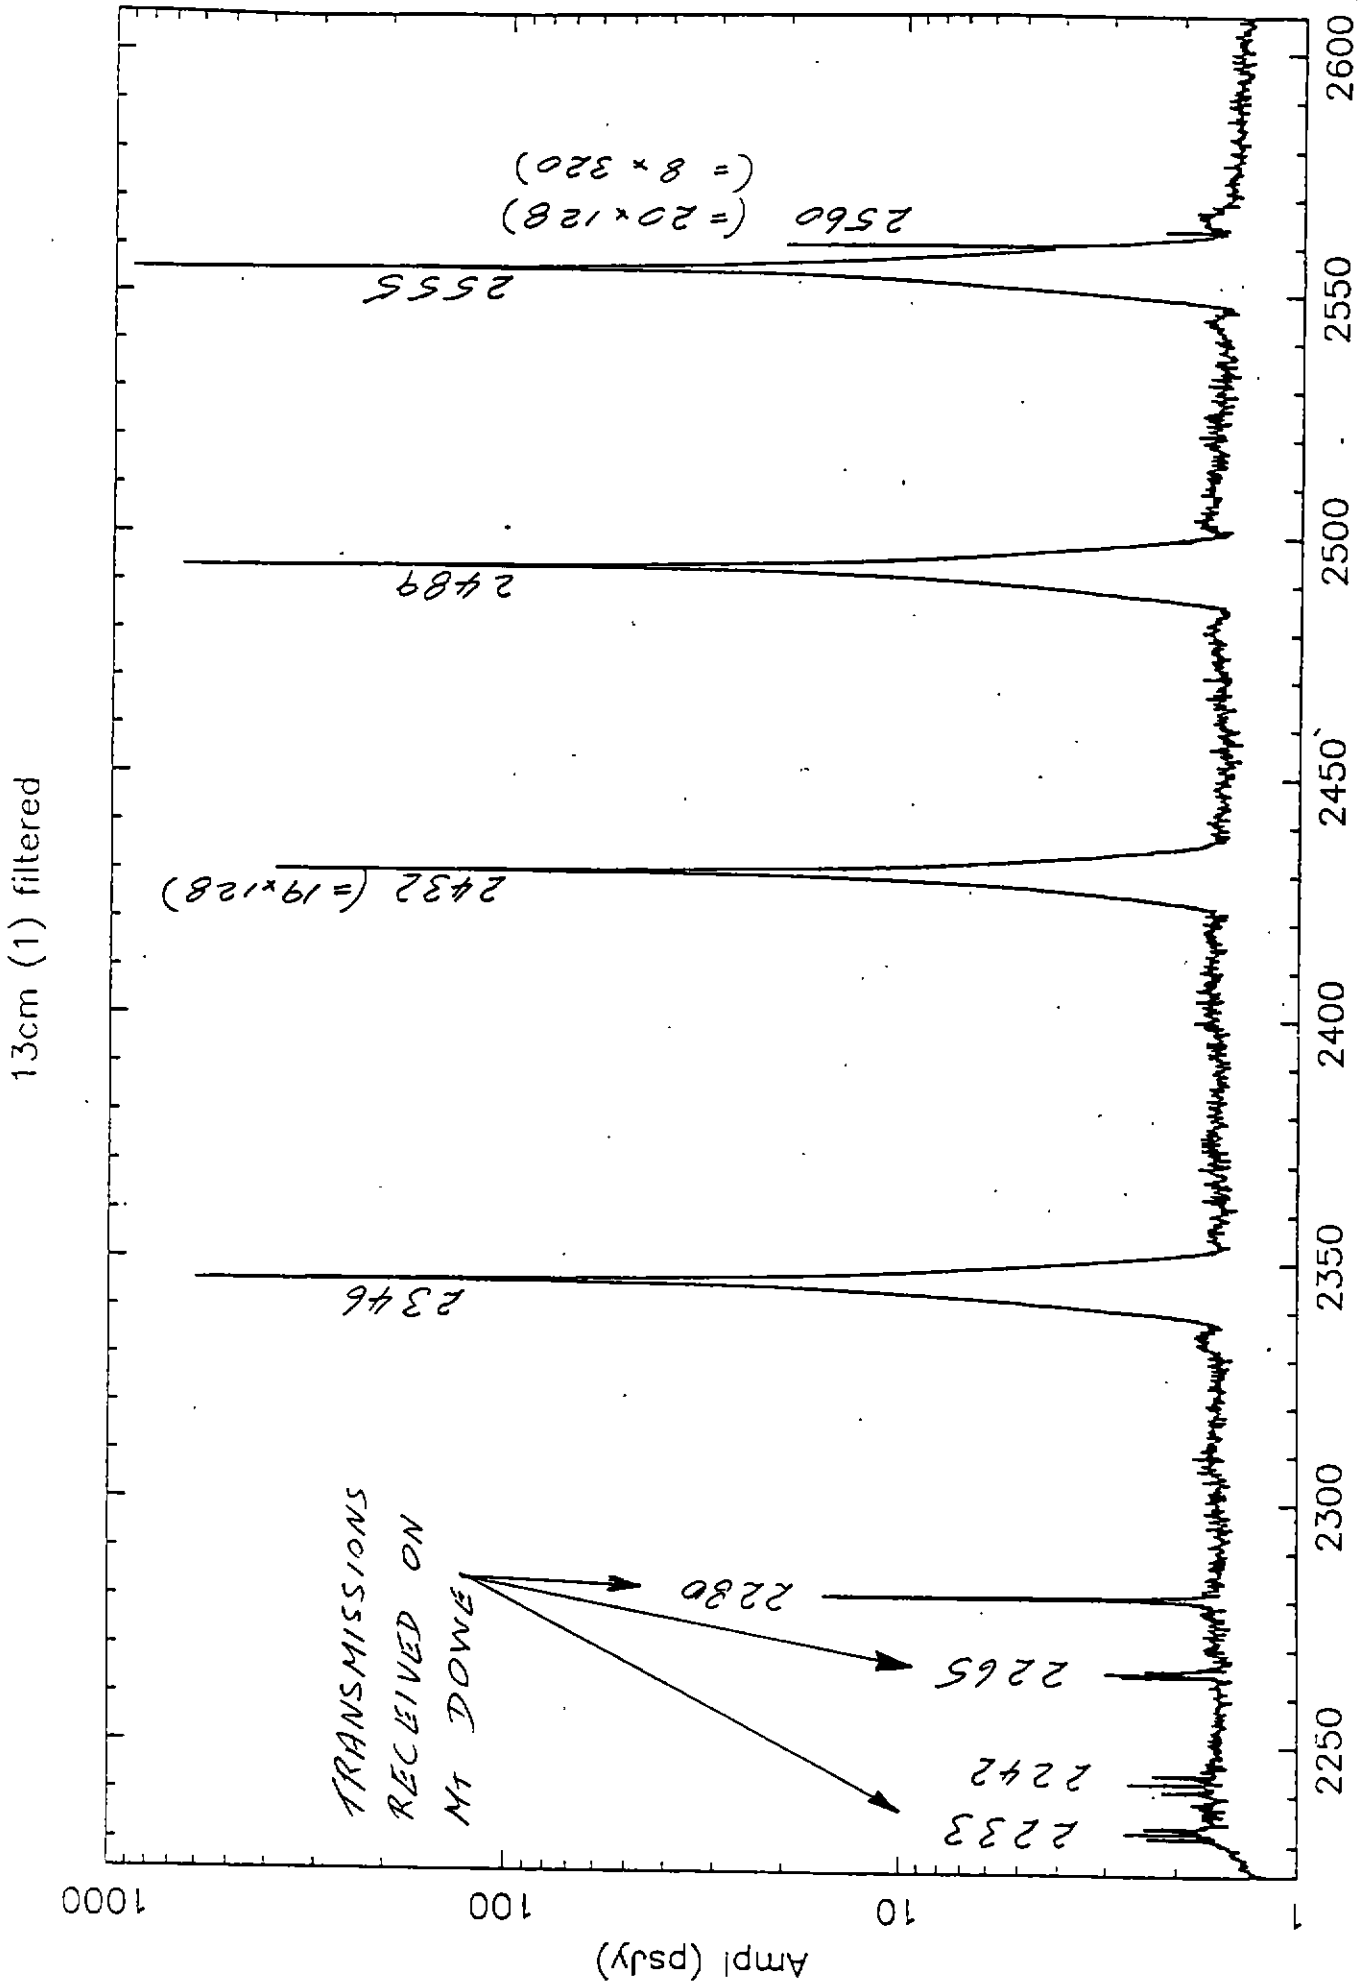
Microwave ovens cause interference in the 13 cm band between 2400 MHz and 2500 MHz.

Fig. 2. Interference in the 13 cm band, taken from [1].

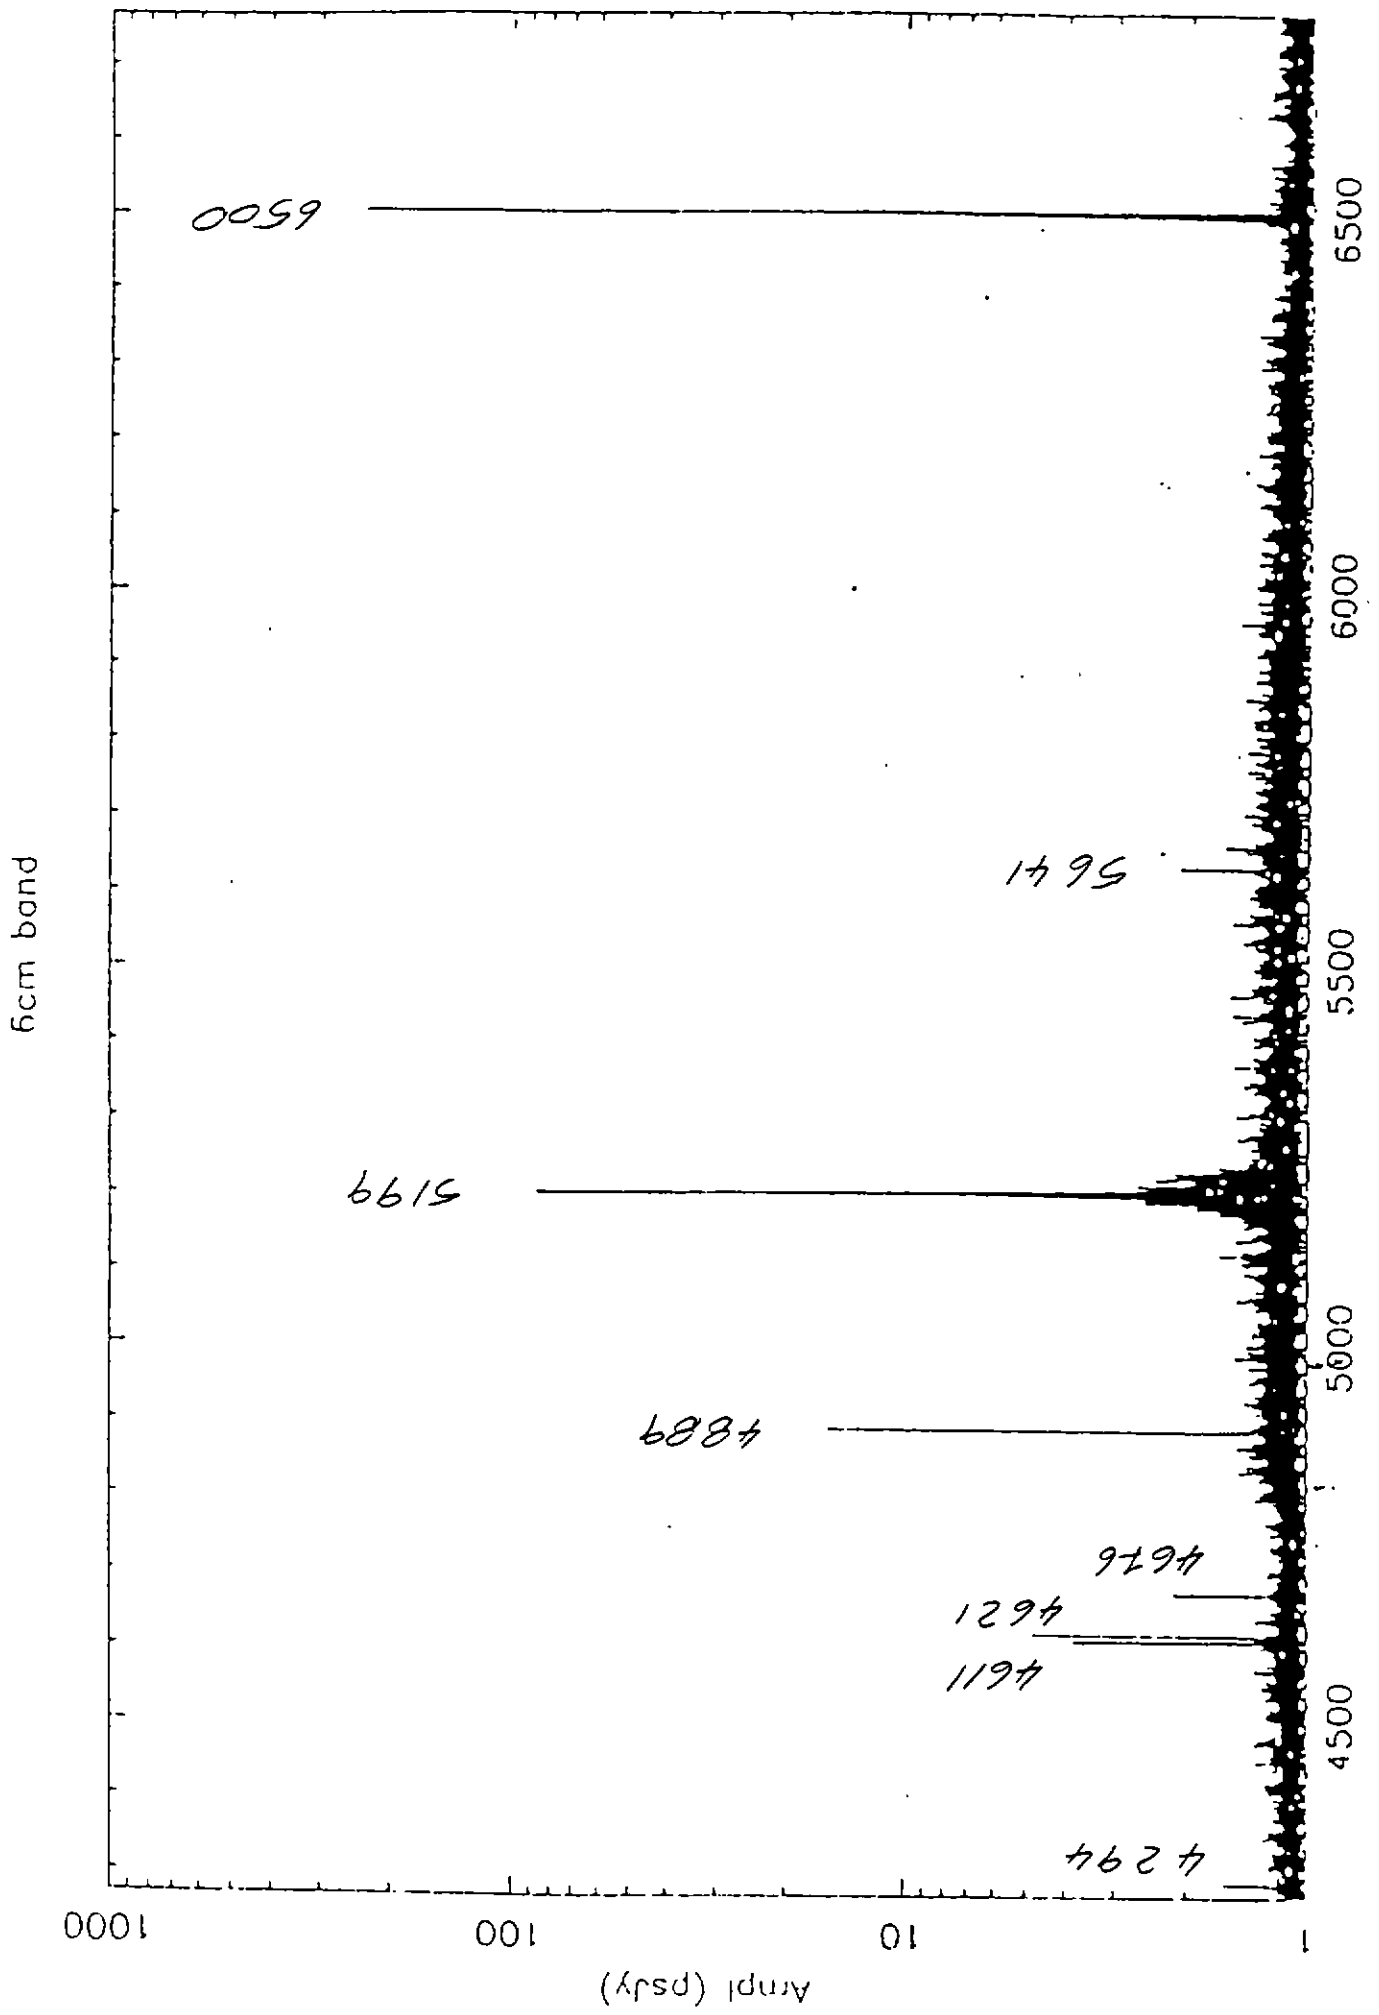
Fig. 3. Interference in the 6 cm band[2].

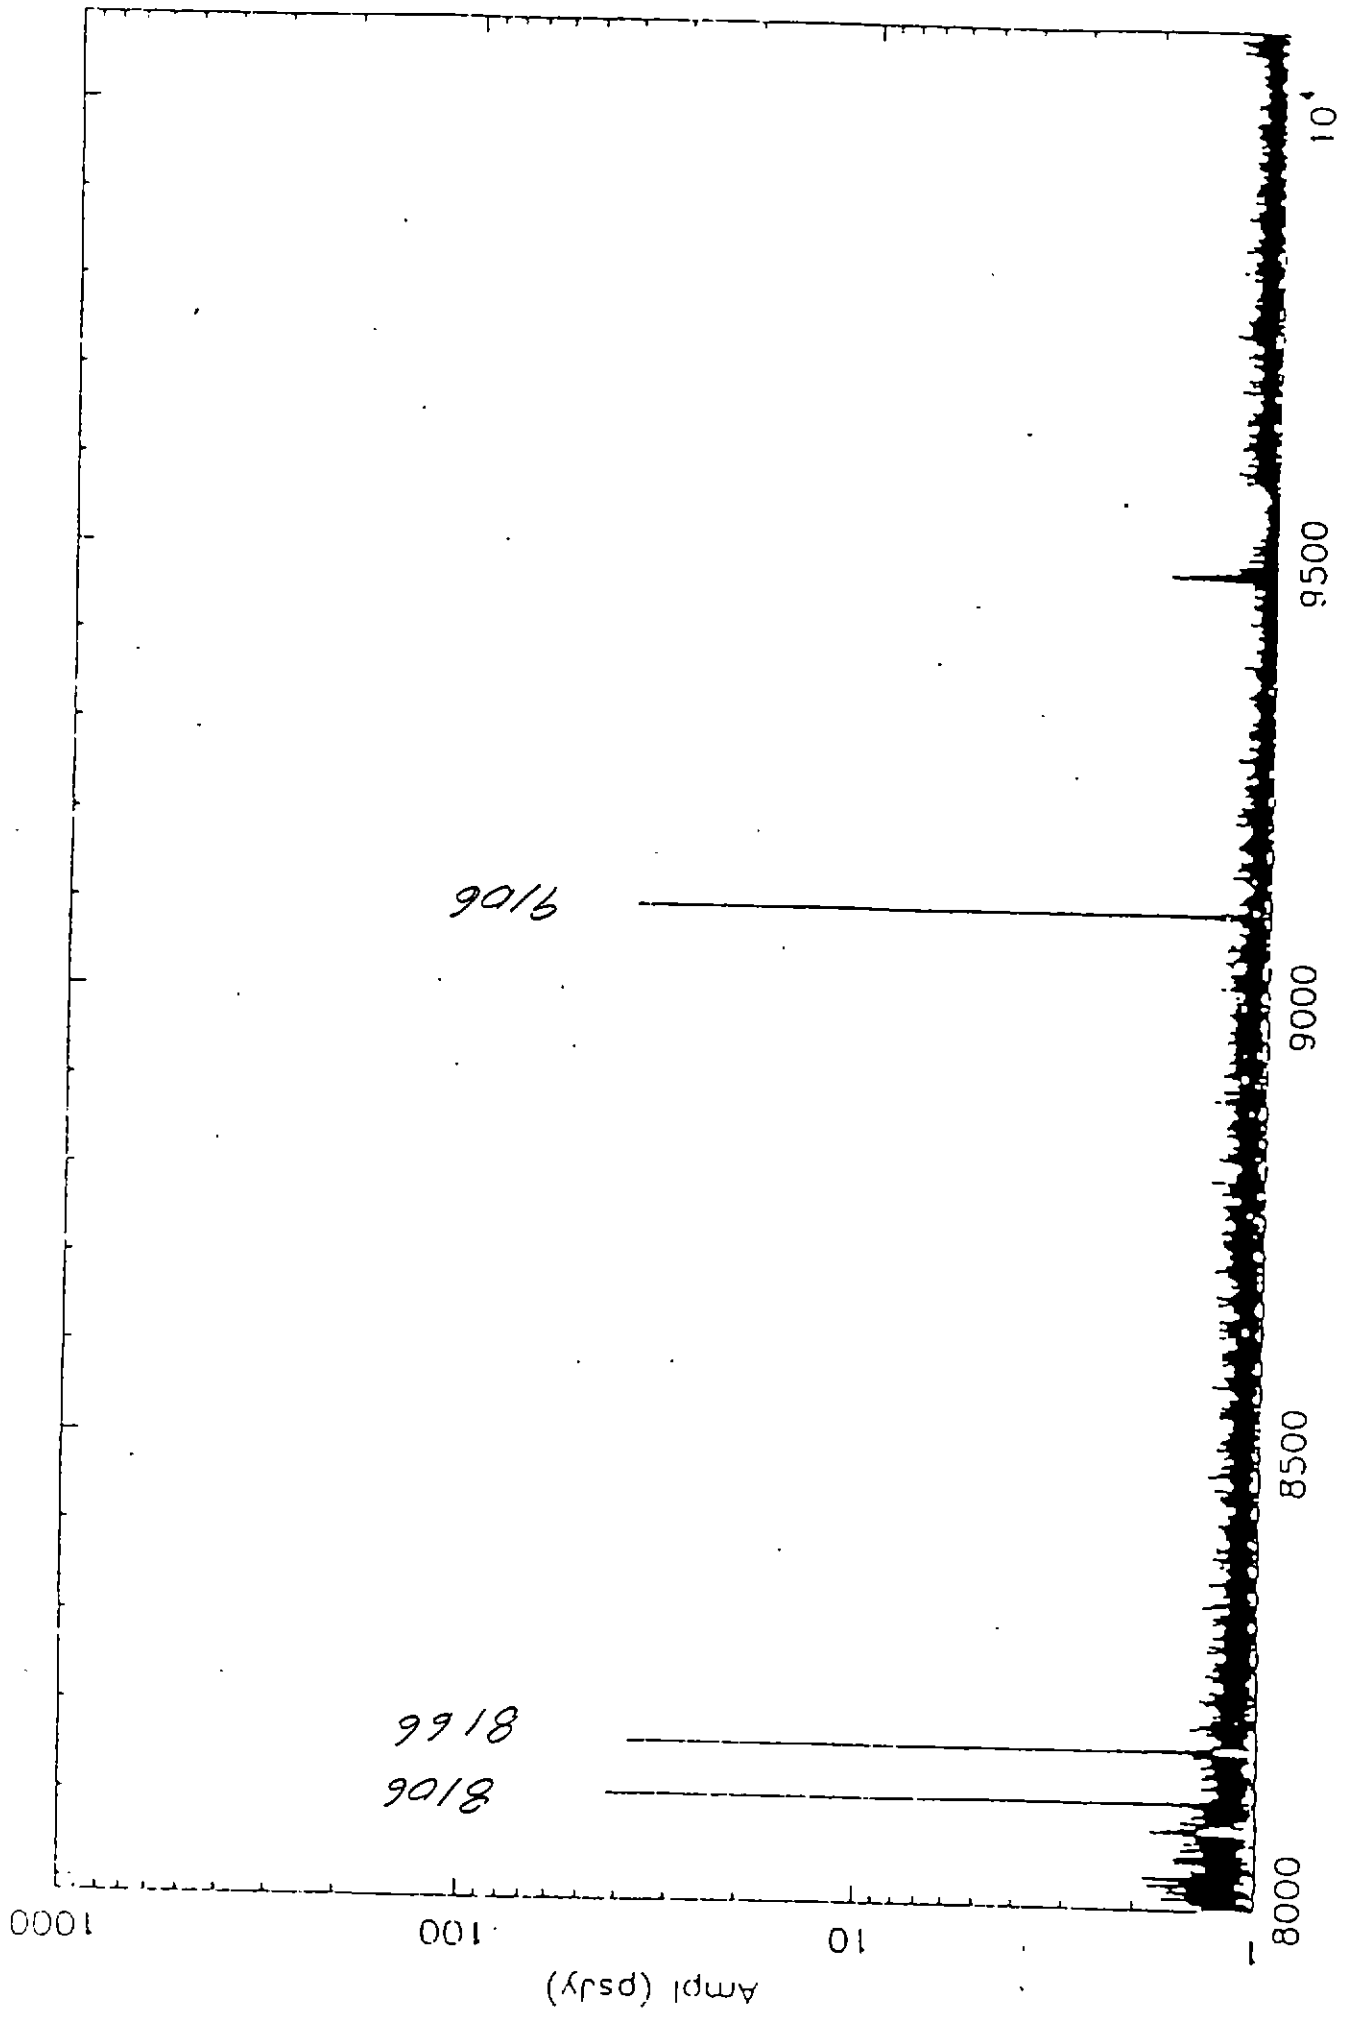
Fig. 4. Interference in the 3 cm band[2].

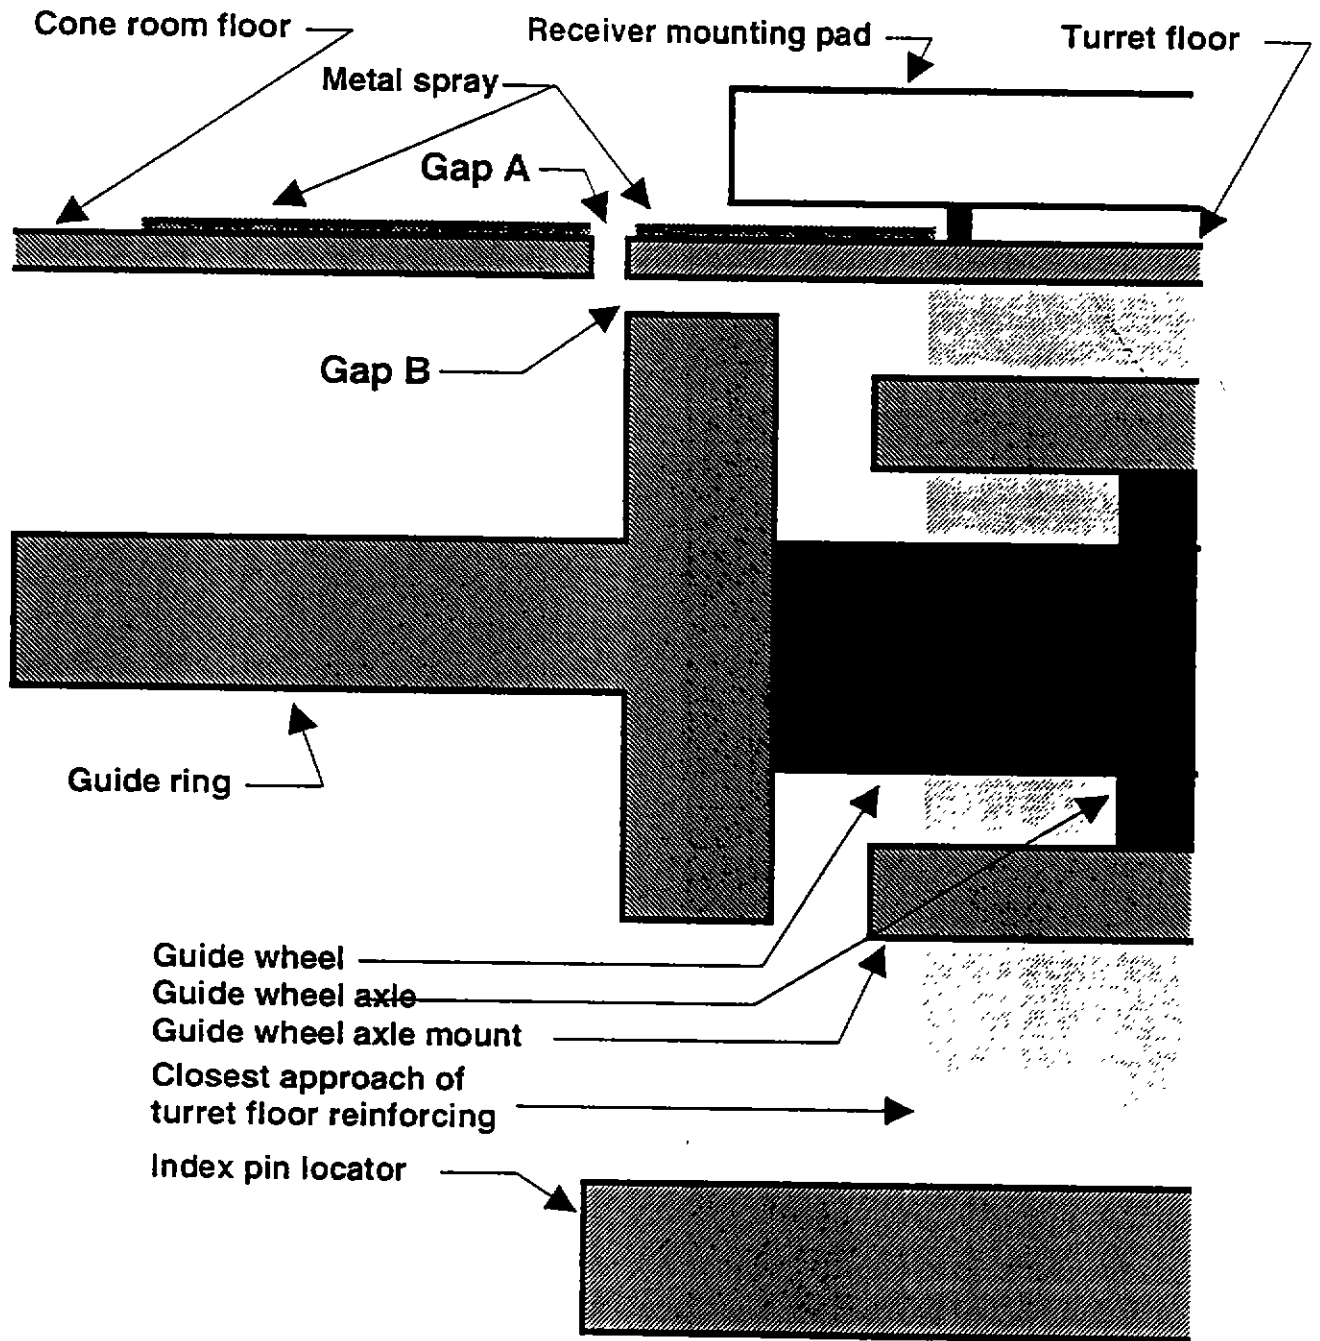
Shielding the small square hole in the floor, and the trapdoor between the vertex room and the cone room is straight forward; I am concerned about the interference that may come through the area around the turret itself. Some options for sealing this gap are described in [3], but we may be able to attenuate this interference by no more than 10 or 20 dB. If this were the case, it would limit the shielding of the vertex room, and sealing the remaining, lower priority, apertures may not significantly improve the system performance.

A cross-section of the is gap in the cone room floor around the turret is shown in Fig. 5. The gap between the cone room floor and the turret floor ( gap A ) varies between 5 and 10 mm, and the gap between the turret floor and the guide ring ( gap B ) varies between 0 and 10 mm. A range of options is described in [3]. It would be best if we could find a "non-contacting" means of shielding the gap around the turret.

**Fig. 5.** Cross-section of the gap in the cone room floor around the turret.

1. The trapdoor between the vertex room and the cone room should be redesigned as described in Section A-2.1.
2. An attempt should be made to shield the gap around the turret as outlined in Section A-2.2.
3. The small square hole in the floor, on the western side of the cone room, can easily be shielded as described in Section A-2.3.

CA02 note : Paint on the metal spray on the cone room floor around the turret will need to be removed mechanically ( or with a suitable solvent ).
