ASKAP Commissioning Update, September 2017

In this issue, we report on recent changes that have been made to ASKAP's digital firmware in response to issues uncovered during commissioning. Several low-level problems have been identified and solved, leading to updates that will increase the stability of the telescope's data acquisition systems.

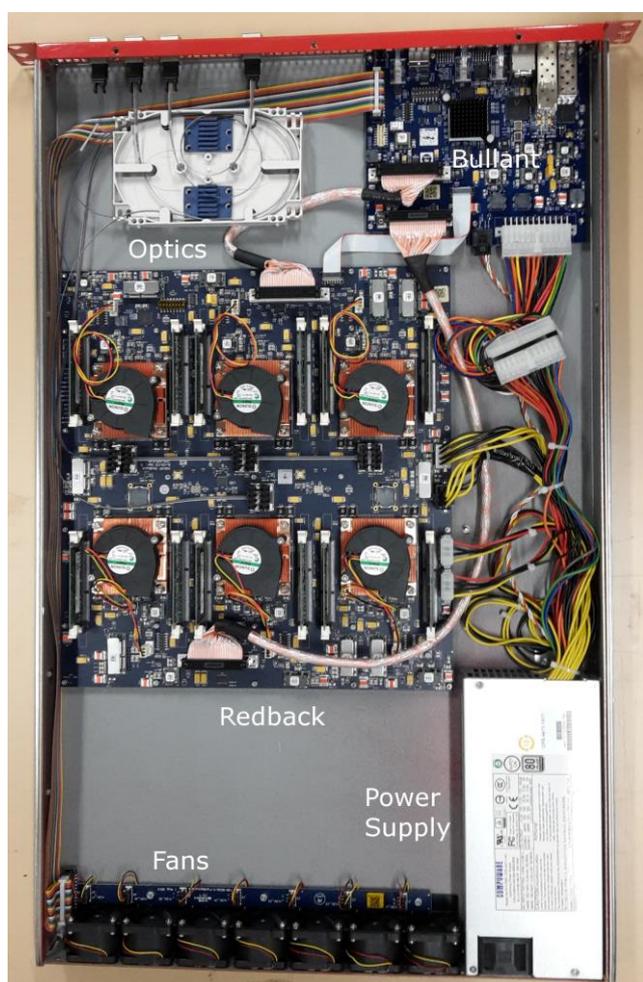
Image: Top-down view of a beamformer chassis with the cover removed to show the components described above.
