# **PARKES RADIOTELESCOPE**

## **REPORT ON TELESCOPE BEHAVIOUR & OPERATION UNDER WIND LOADING CONDITIONS**

**CONNELL WAGNER (NSW) PTY LTD  
ACN 003 505 673  
116 Military Road  
NEUTRAL BAY NSW 2089**

**APRIL 1993**

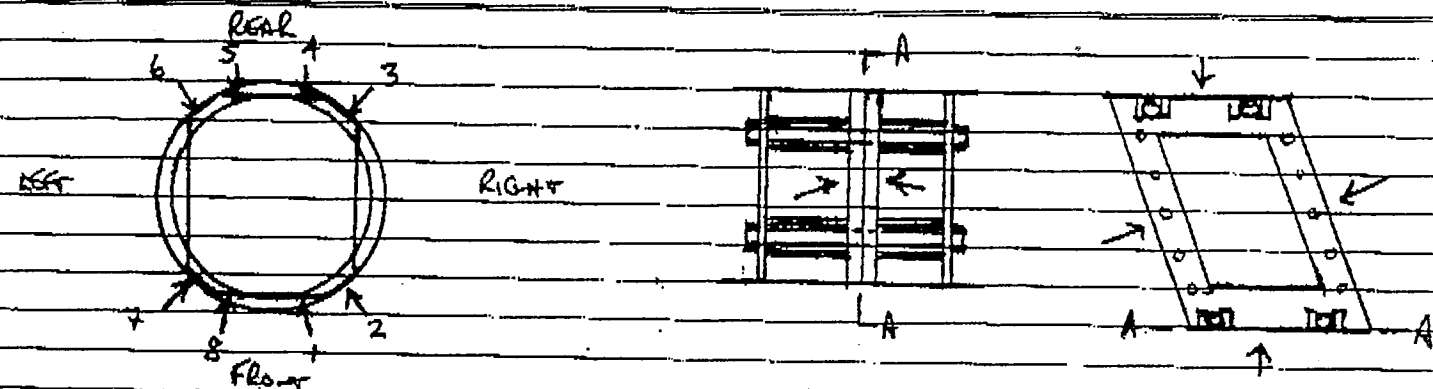
→ AREA OF INSPECTION (APPROX 90°)

WELD 1:- INTERIOR FLUET	- NO ACCESS SPACE FILLED WITH CONCRETE
EXTERNAL BUTT	- 230mm OF WELD NO EVIDENCE OF CRACKING FOUND
WELD 2:- INT. FLUET	- NO EVIDENCE OF CRACKING FOUND
EXT BUTT	- 140mm OF WELD NO EVIDENCE OF CRACKING FOUND
WELD 3:- INT. FLUET	- NO EVIDENCE OF CRACKING FOUND
EXT BUTT	- 100mm OF WELD NO EVIDENCE OF CRACKING FOUND
WELD 4:- INT FLUET	- NO EVIDENCE OF CRACKING FOUND
EXT BUTT	- 100mm OF WELD CRACKED RIGHT THROUGH
WELD 5:- INT FLUET	- NO EVIDENCE OF CRACKING FOUND
EXT BUTT	- 420mm OF WELD NO EVIDENCE OF CRACKING FOUND
WELD 6:- INT FLUET	- NO EVIDENCE OF CRACKING FOUND
EXT BUTT	- 110mm OF WELD CRACKED FOR 50mm FROM BOTTOM EDGE
WELD 7:- INT FLUET	- NO EVIDENCE OF CRACKING FOUND
EXT BUTT	- 140mm OF WELD NO EVIDENCE OF CRACKING FOUND
WELD 8:- INT FLUET	- NO EVIDENCE OF CRACKING FOUND
EXT BUTT	- 420mm OF WELD NO EVIDENCE OF CRACKING FOUND

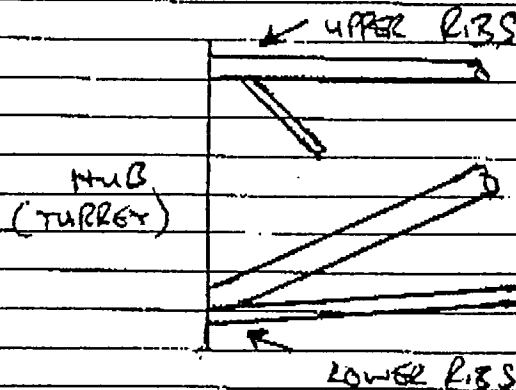
RIBS NUMBERED ANTI-CLOCKWISE FROM VERTICAL LADDER BETWEEN UPPER AND LOWER RIBS

UPPER RIB 3 - NO EVIDENCE OF CRACKING FOUND

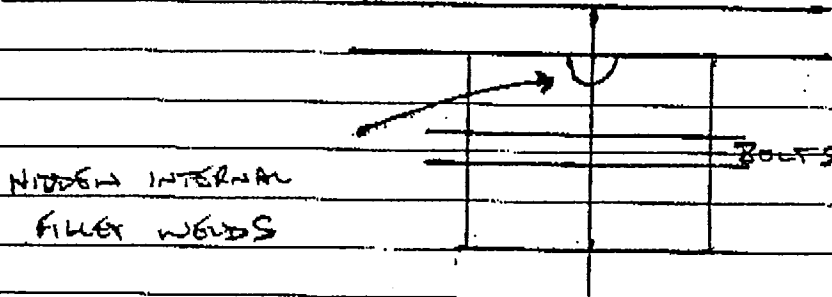
**FOR LOCATIONS REFER TO NN89-123 u/1 WORKSHEET NO 3480**

**WELD 1 - WELD CONFIRMED - NO EVIDENCE OF CRACKING FOUND**

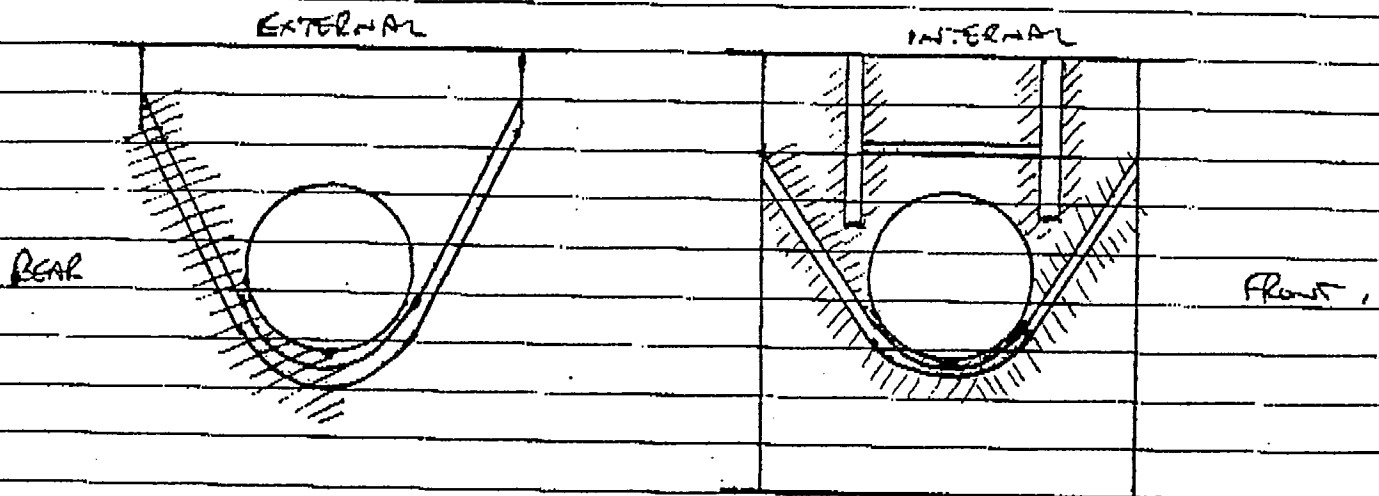
SHADED AREAS SHOW EXTENT OF TEST

LEFT HAND SIDE EXTERNAL - NO EVIDENCE OF CRACKING FOUND

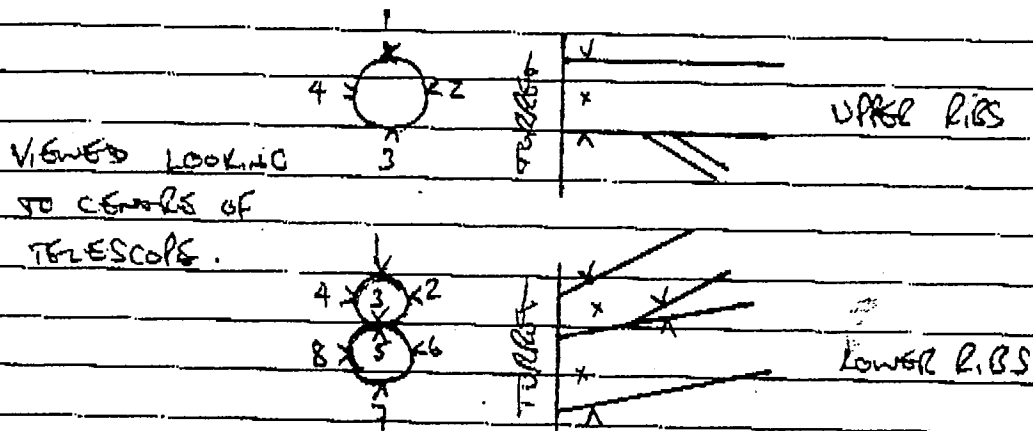
RIBS NUMBERED AS PER MS9-123 M/3 WORKSHEET NO 3482

1	2	3	4	5	6	7	8
UPPER RIB 3 -	7.5	8.0	7.75	7.75	-	-	-	-
15 -	8.0	8.5	8.5	8.25	-	-	-	-
23 -	7.25	7.5	7.75	7.5	-	-	-	-
LOWER RIB 4 -	8.25	8.25	8.25	8.0	7.5	7.5	7.5	7.75
5 -	8.25	8.0	8.25	8.0	7.75	8.25	8.0	7.5
12 -	8.5	8.5	8.25	8.25	8.0	8.75	8.25	7.75
13 -	8.5	8.5	8.5	8.5	8.0	8.0	7.75	7.5
25 -	7.25	8.0	8.5	8.0	8.5	7.5	7.75	8.0
26 -	7.5	7.5	8.0	8.0	7.25	8.25	8.25	7.75
