CSIRO DIVISION OF RADIOPHYSICS

SIDING SPRING A.T. INTERFERENCE SURVEY I

~~AT/15.77012~~ AT/15.5/012

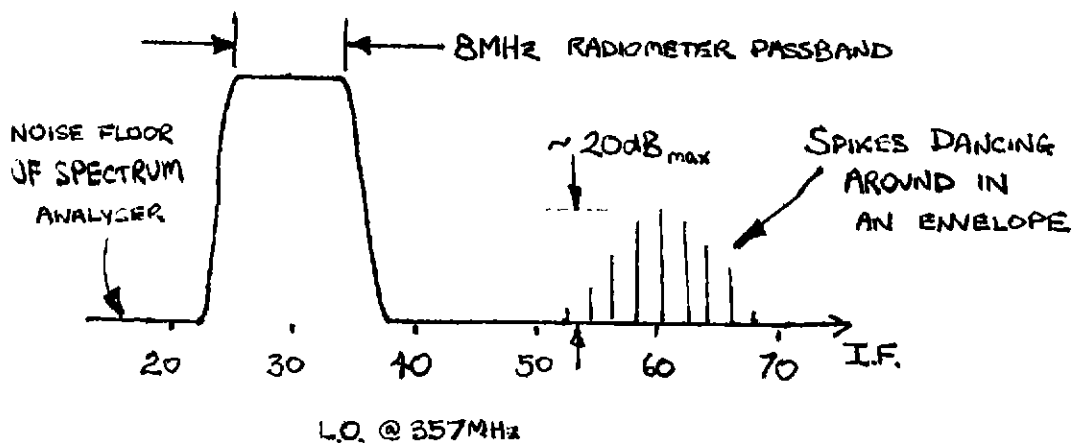
An interesting signal however was observed outside the passband of the system and was above the noise floor of the spectrum analyser. The appearance was as follows.

This signal had some observable correlation with the average power variation hence may be the source of the interference. Clearly it must be a very strong signal before the attenuation. Otherwise the interference is probably broadband.

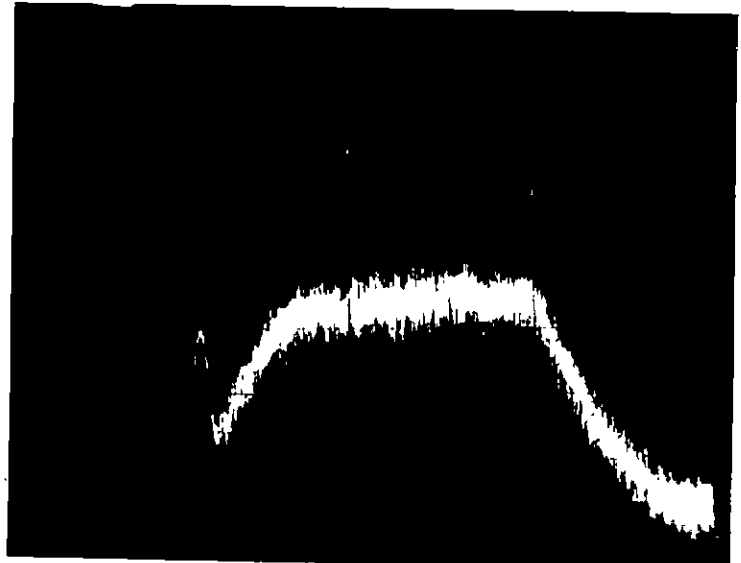
Scales: 2MHz/div Horizontal
10dB/div Vertical

Data: 300kHz Bandwidth
438.02MHz LO
408MHz CF
45° Polarization

Class (iii) Strong, swept frequency signal. It registered as in photographs #3 and #5 on the spectrum analyser as very narrow tall spikes. These spikes moved rapidly across the observing passband. The nature of its appearance on the photograph is due to the sampling characteristic of the spectrum analyser. The spike representing a single sample of the swept signal's modulation envelope. At max sweep rate on the spectrum analyser the complete modulating envelope was fleetingly visible. Level was approximately 25dB above system noise. This was an unlisted transmission.
