AT Technical Data
AT39.2/020
November 22, 1993

THE AUSTRALIA TELESCOPE NATIONAL FACILITY
PHASE JUMPS IN THE AT PHASE ROTATOR MODULES

Andrew Bish

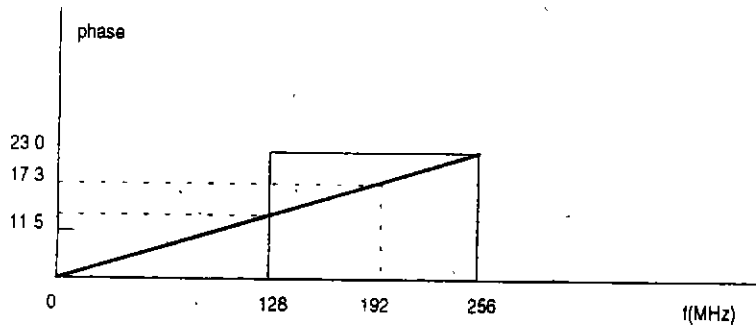
Figure 4: Phase vs. Frequency Relationship
The average phase for the 128-256MHz bandwidth is 17.3 degrees.

For the 128MHz bandwidth, which extends from 128-256MHz, the phase error varies from 11.5° to 23° (from (2)). The average phase change is that at the center of the band (192MHz), i.e. 17.3°, as shown in the diagram below:
